SM 5 BSZ - Dynamic Range of 2 m Transceivers Part 2: Modifications to the TS 700

Published in VHF communications Nr 2 1982.

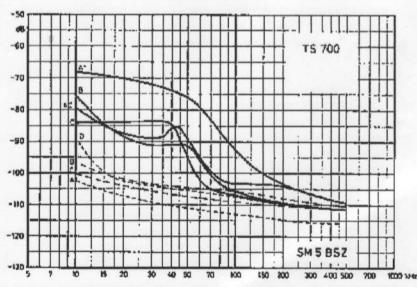
The noise sidebands that accompany the transmit signal of the TS700 are relatively strong at a spacing of +/-100 kHz or less. They originate in the DC-converter of the power supply circuit. The converter produces a 600 Hz square-wave signal. The steep slope results in spikes that cause an amplitude modulation of the transmiMer, which in turn increases the signal bandwidth to +/-100 kHz.

Figure 1 shows the noise sidebands of some TS700 transceivers before modification (continuous lines), and after modification (dashed lines).

The curves designated with "A¢ are from an older unit, which was defective during the first measurement (A 1). The cause for this were loose nuts used for mounting the board in the power supply. After tightening the four nuts, the transceiver exhibited normal, typical values (A 2). After publishing this article in "Radio och Televisiom" the author received a number of letters that indicated that many such transceivers have this problem.

Fig. 1: In the TS700 the noise sidebands are caused by 600 Hz pulses from the DC converter. Massive lines = 4 different transceivers in their original states; broken lines = after modification

Curves B and C are from transceivers of more modern construction. Transceiver D was only measured after modification; it is not known whether it is an older or newer model.

1. The first step in improving the interference sidebands of the TS700 is thus simple: Tighten these nuts so that the power supply has a good ground connection.

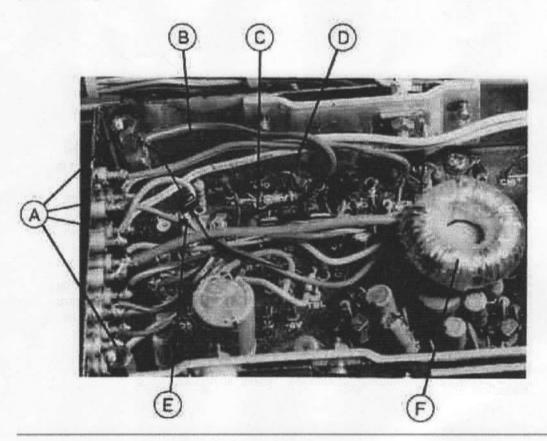
Fig. 2: These are the modifications:

Very high currents of the 600 Hz spikes flow within the power supply. The selection of the ground points is therefore very critical. The ground points of the 9 V stabilizer have not been carefully selected, and for this reason, the second and third steps of the modifications are in improving the ground connections of the 9 V stabilizer circuit. These are carried out as follows:

- A: Tighten all 4 bolts
- B: Soldera heavywirefromthebolt in the upper left-hand corner to pin 1 of Q11
- C: Cut the old resistor
- D: Put in the new 1 kiloohm resistor
- E: This iswhere the 220 microfarad electrolytic capacitor finds its place
- F: The toroid-core choke

2. The ground pin of the integrated stabilizer (Q11, pin 1) is connected to one of the previously mentioned nuts by connecting a copper wire of at least 2.5 mm diameter from the upper side of the IC to the nut, and soldering it into place. That nut should be used that is nearest to the 144 MHz power amplifier.

3. The ground end of R28 is now connected to pin 1 of Q11. The upper end of R28 is now cut and a new 1 kiloohm resistor connected from the loose end of R27 to pin 1 of Q11 (from above).

4. Unsolder the connection from the 9 V stabilizer to the transceiver and insert an AF choke. Since this is not critical, a readily available Ferrite toroid core (material 4 C 6 violet) was used whose dimensions were 23 x 14 x 7; it was then provided with 30 turns of enamelled copper wire of 0.8 mm diameter. The choke should have an inductance of 50 microhenry or more, and exhibit a low stray field. The toroid cores should be insulated with a little plastic tape and clamped into position between an electrolytic capacitor and the cover of the power supply.

5.Solder an electrolytic capacitor of 220 microfarad or more from the - 6 V connection of the power supply to the nut that is already used as ground point for Q11 described in step 2.

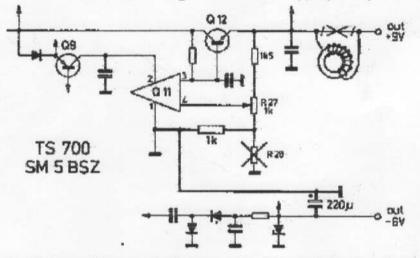
6.Solder an electrolytic capacitor of 1000 microfarad or more between fuse F2 (2 A) in the 20 V line and the ground point at the center of the rear panel. Figure 2 shows the modifications 1 to 5, and Figure 3 shows the appropriate part of the circuit.
